# Environmental Team Services for Contract No. SS H504 Design and Construction of Chai Wan Government Complex and Vehicle Depot

## 37<sup>th</sup> Monthly EM&A Report (November 2024)

**Contract No. SS H504  
Design and  
Construction of Chai  
Wan Government  
Complex and Vehicle  
Depot**

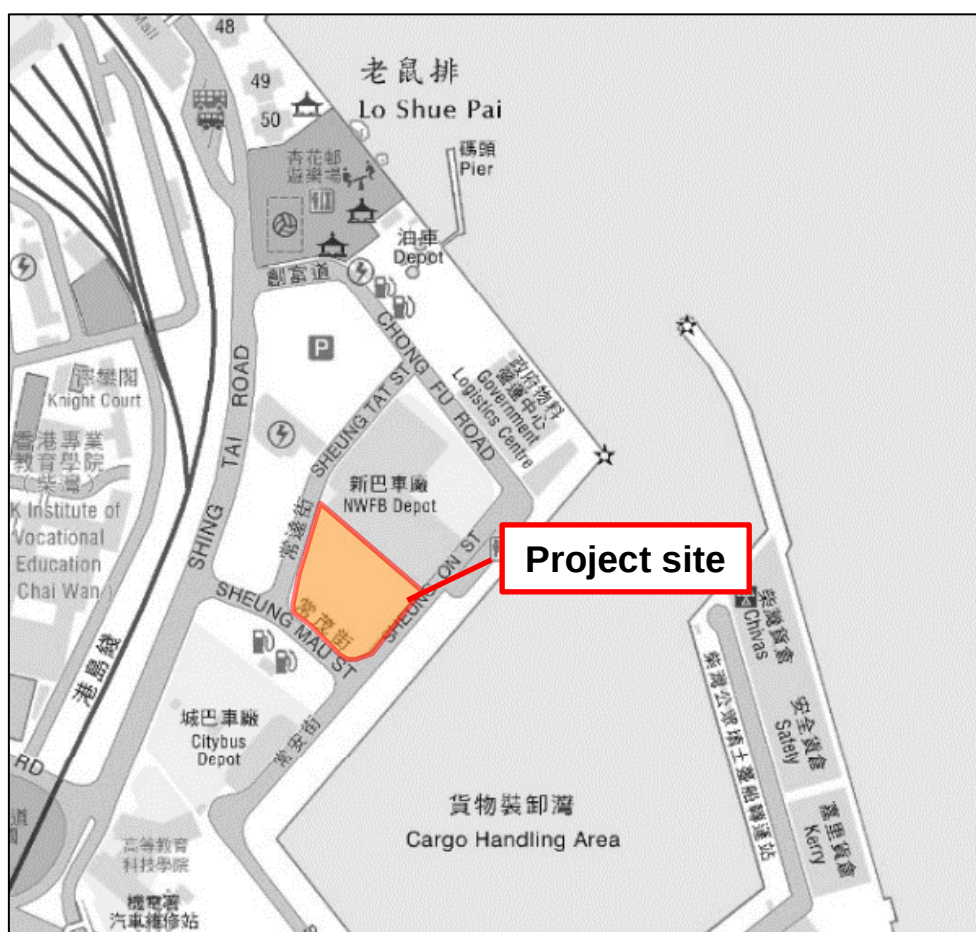
**Figure 1-1      A layout plan of the Project**

2.2.1 The scope of works of the Project, which is a Designated Project under the EIA Ordinance (EIAO), will construct joint user building comprising the government office, store, laboratory, transport pool and vehicle depot facilities in Chai Wan District. The Site is bounded by NWFB Depot to the north, Sheung On Street to the east, Sheung Mau Street to the south and Sheung Tat Street to the west. A layout plan of the Project is provided in **Figure 1-1**.

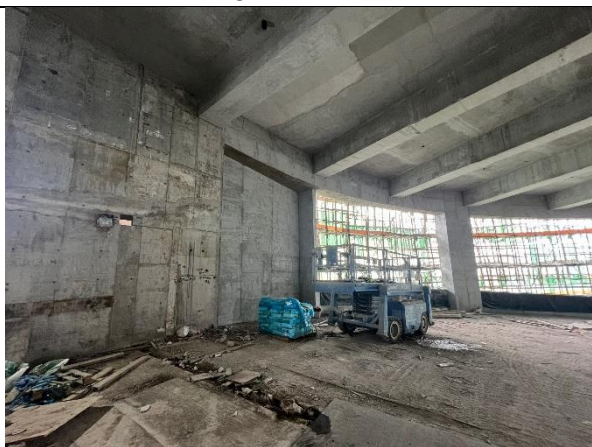
Photo R3

1. The C&D waste and general waste were removed and disposed. (Photo R3-R4)

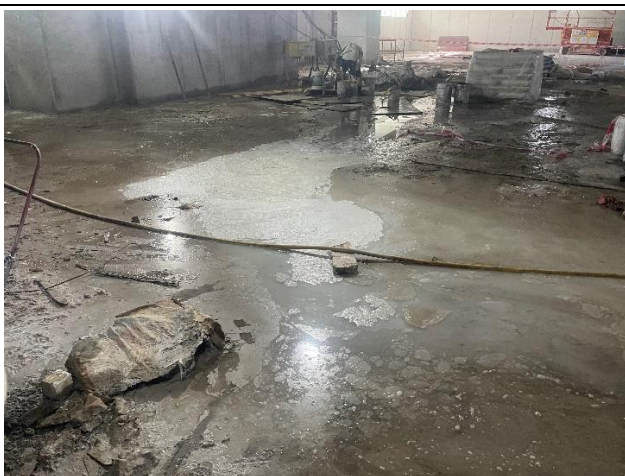
Photo 1

1. The wastewater is accumulated on the floor. (Photo 1)
2. The general waste is mixed with C&D waste. (Photo 2)
3. The oil stain is observed in the work area. (Photo 3)

1. The Contractor has been recommended to properly collect wastewater for water treatment.
2. The Contractor has been advised to increase the frequency of waste disposal to prevent waste accumulation and to provide enclosed bins or a segregation area for general waste to ensure proper segregation.
3. The Contractor has been reminded to clean the oil stain immediately and dispose of it as chemical waste.

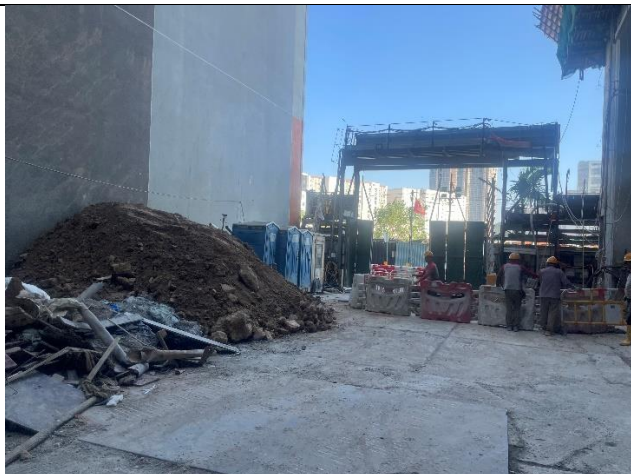
Photo 1

1. Stockpiling of dusty material without impervious sheet is observed. (Photo 1)
2. The worksite is dusty, and dust fugitive is observed. (Photo 2)
3. C&D waste, general waste and chemical waste without segregation is observed. (Photo 3-5)

1. The Contractor has been reminded that stockpiling dusty materials should be covered with impervious sheeting and removed or backfilled within 24 hours of excavation or unloading.
2. The Contractor has been advised that the worksite should be regularly watered to ensure the work area is wetted and to prevent dust dispersion.
3. The Contractor has been recommended to provide sufficient rubbish bins with lid and other segregation skips/bins for proper disposal of general refuse and segregation of different type of waste.

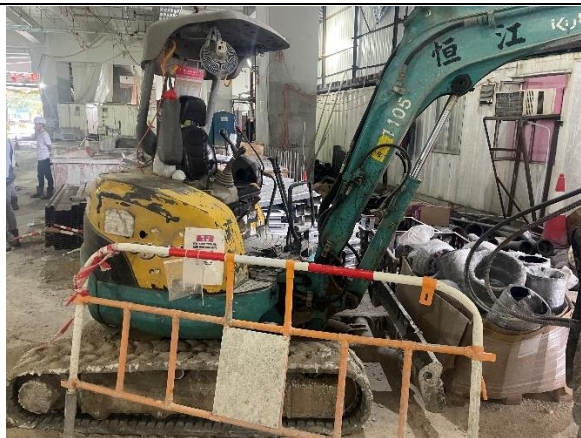
Photo 1

1. Breaker without NRMM label is observed. (Photo 1)
2. The accumulated of general waste is found on the floor. (Photo 2)

- Breaker without NRMM label was observed. The Contractor has been reminded that NRMM label should be affixed on the breaker.
- The accumulated of general waste was found in the floor. The Contractor has been advised that the frequency of waste disposal or the number of enclosed bins should be increased to avoid waste accumulation.

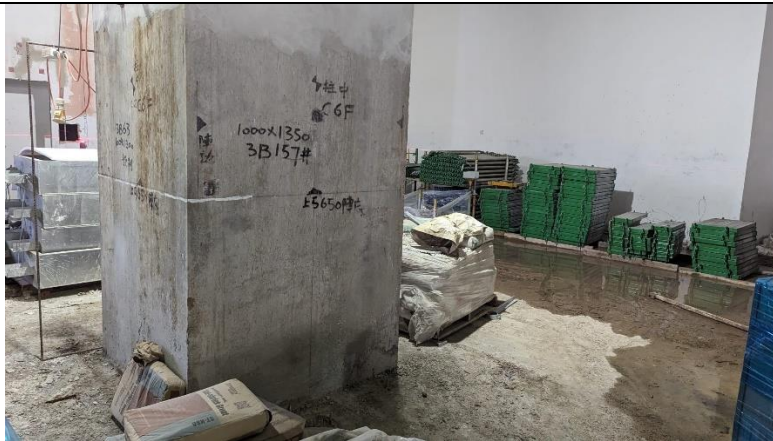
Photo R3

1. The accumulated of waste was removed. (Photo R3)

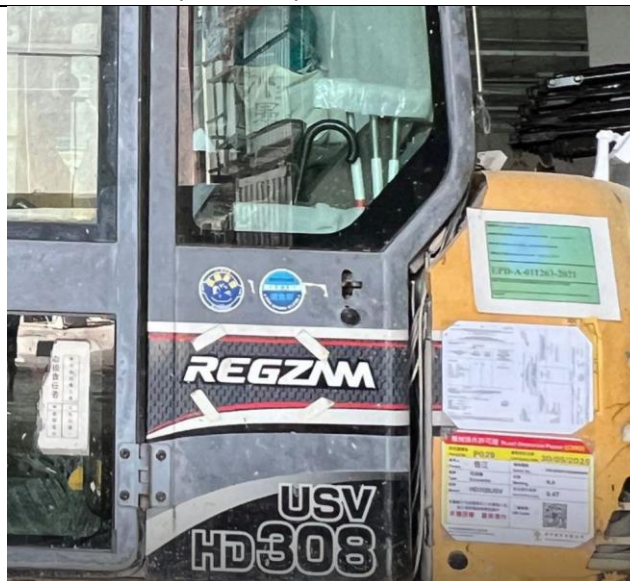
Photo R4

1. NRMM label was affixed on the breaker. (Photo R4)

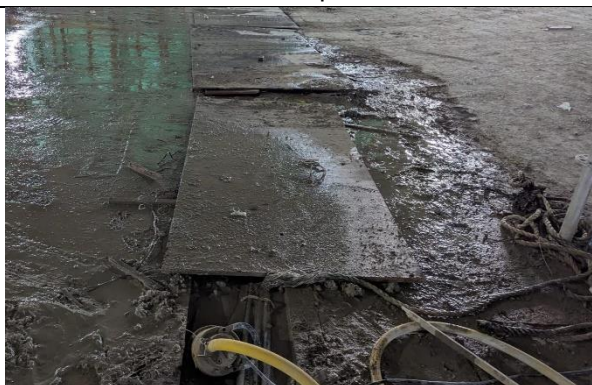
Photo R5

1. The pump was provided, and the drainage was cleaned. (Photo R5)
2. C&D waste storage area was designed. (Photo R6)
3. Chemical containers were placed in the chemical cabinet. (Photo R7)

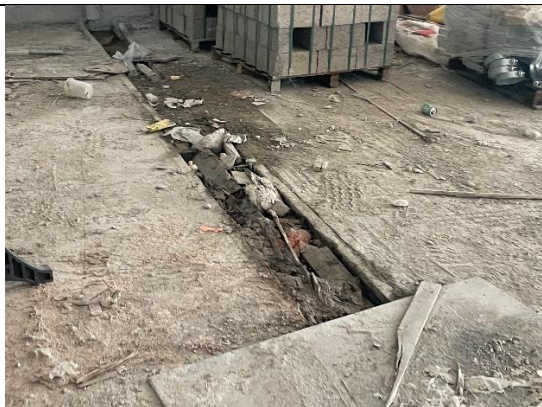
Photo 1

1. The accumulated of construction waste and soil in the L3 drainage channel is observed. (Photo 1)
2. The accumulated of C&D waste is found on the L3 floor. (Photo 2)
3. Chemical wastes and dry PFA packaging waste in L3 should be stored properly and separately before disposed. (Photo 3)

- The accumulated of construction waste and soil in the L3 drainage channel was observed. The Contractor has been reminded that the drainage channel should be cleaned regularly to prevent the accumulation of construction materials and soil in drainage channel.
- The accumulated of C&D waste was found on the L3 floor. The Contractor has been advised to design the C&D waste storage area for effective waste collection and to increase the frequency of waste disposal to prevent accumulation.
- Chemical waste and dry PFA packaging waste in L3 should be stored properly and separately before disposed. The Contractor has been advised that chemical waste/containers should be separated from dry PFA packaging waste to prevent waste contamination.
