# Environmetnal Team Services for Contract No. SS H504 Design and Construction of Chai Wan Government Complex and Vehicle Depot

39th Monthly EM&A Report (January 2025)

Contract No. SS H504
Design and
Construction of Chai
Wan Government
Complex and Vehicle
Depot

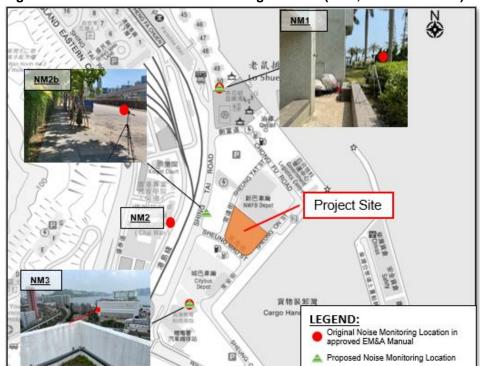
Figure 3-1 Location of Noise Monitoring Stations (NM1, NM2b and NM3)

Lamp Post no. 47447 at Sheung Mau Street (NM2a), which is located between project site and original noise monitoring location, Hong Kong Institute of Vocational Education (Chai Wan) - Academic Block (NM2), is found suitable and available to be an alternative noise monitoring location for NM2. Also, NM2a, which has a direct line of sight towards project site (where construction works will be carried out and likely to have noise impacts), is located closer to project site than NM2 and thus considered as a representative noise monitoring location. Monitoring position at NM2a is proposed at 2m above ground due to security concerns and minimize the road traffic noise contribution. Noise measurement at NM2a will be considered as free-field and a correction of +3dB(A) would be made to the noise monitoring results. The alternative location of NM2a, were therefore proposed and agreed by the Independent Environmental Checker (IEC).

To respond to the comment raised by EPD on monitoring location of NM2a by email dated 23 May 2022 and site meeting on 6 June 2022, the monitoring location of NM2a was adjusted to the pedestrian road at Shing Tai Road (NM2b) which is located between project site and original noise monitoring location, Hong Kong Institute of Vocational Education (Chai Wan) - Academic Block (NM2). Compared with NM2a, NM2b is far away from the traffic light and therefore should be able to minimise the traffic noise issue. This arrangement was started from 28 June 2022 and has been agreed by the Independent Environmental Checker (IEC). Noise measurement at NM2b will be considered as free-field and a correction of +3dB(A) would be made to the noise monitoring results.

Due to the adjustment of the location of NM2a to NM2b, the measured noise level at NM2b would represent the noise levels at NM2.

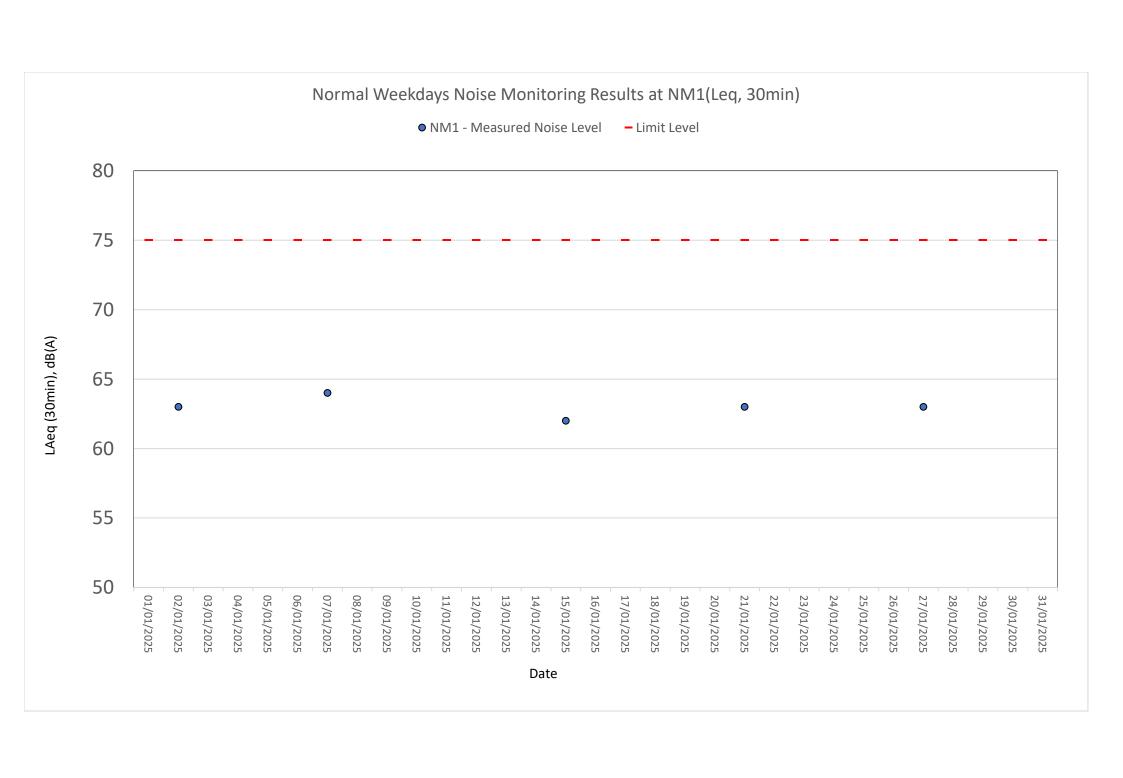
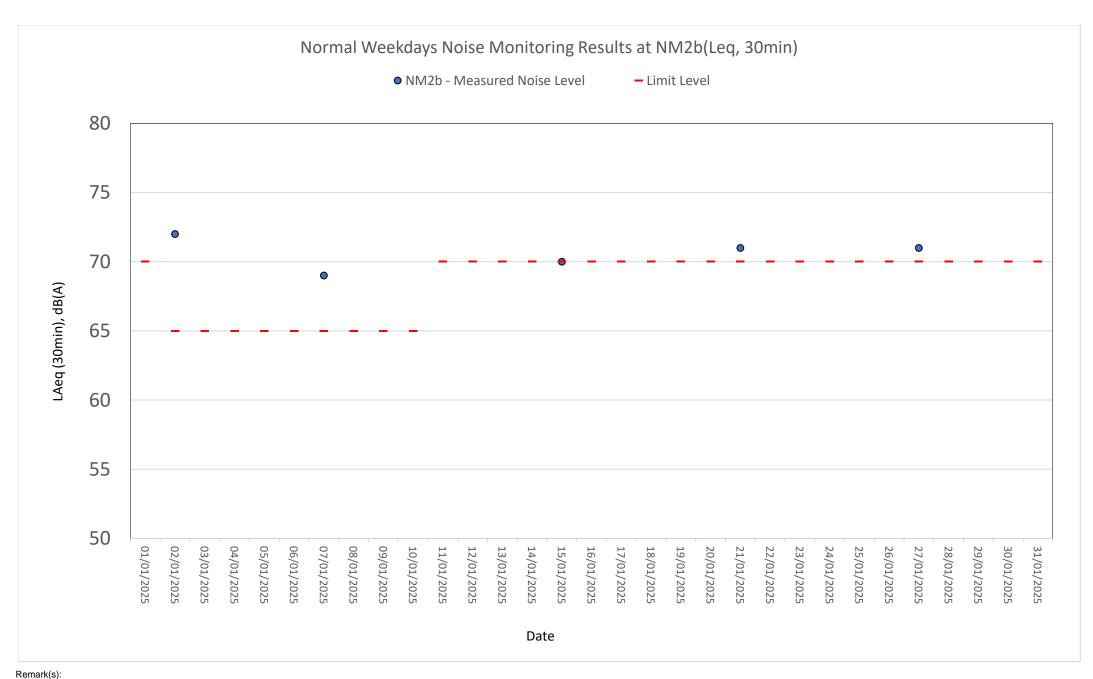
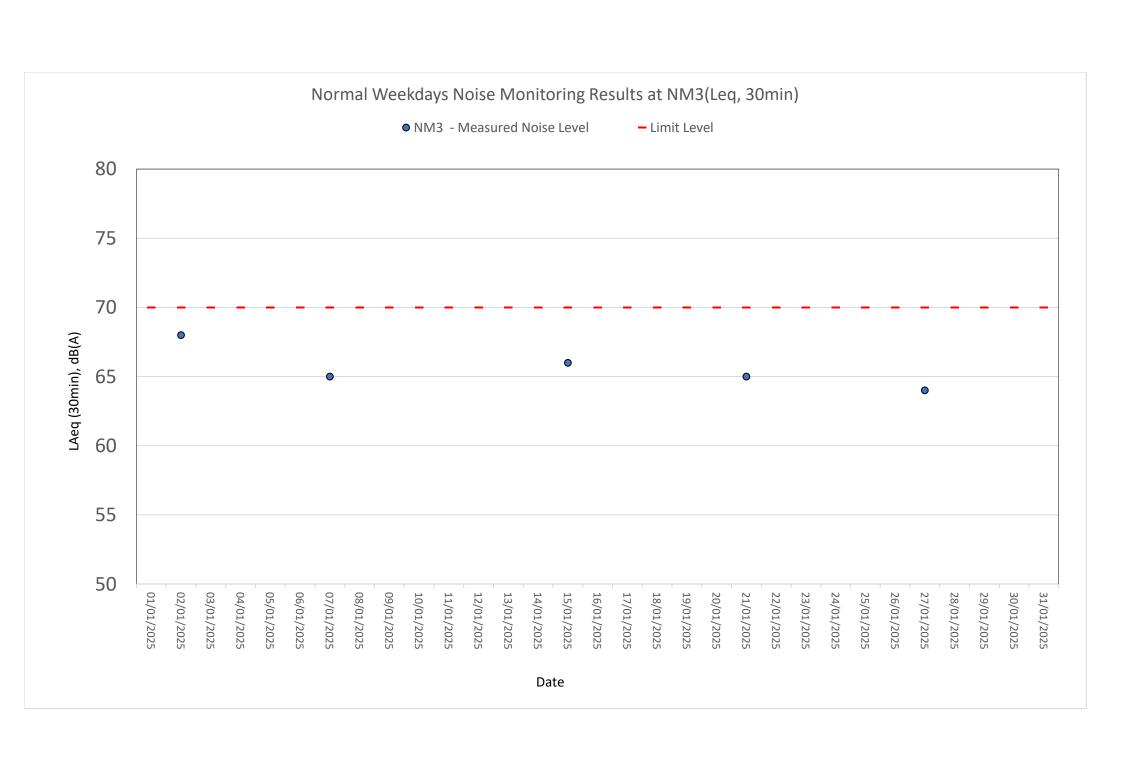
# On O2 and O7 January 2025, the measured noise levels of NM2b exceeded the limit level of 65 dB(A) as they were within exam period. However, they were lower than the baseline level of 73.4 dB(A). Therefore, they are not considered as an limit level exceedance.

^ On 21 and 27 January 2025, the measured noise levels of NM2b exceeded the limit level of 70dB(A). However, they were lower than the baseline level of 73.4 dB(A). Therefore, they are not considered as an limit level exceedance.

On 02 and 07 January 2025, the measured noise levels of NM2b exceeded the limit level of 65 dB(A) as they were within exam period. However, they were lower than the baseline level of 73.4 dB(A). Therefore, they are not considered as an limit level exceedance. On 21 and 27 January 2025, the measured noise levels of NM2b exceeded the limit level of 70dB(A). However, they were lower than the baseline level of 73.4 dB(A). Therefore, they are not considered as an limit level exceedance.

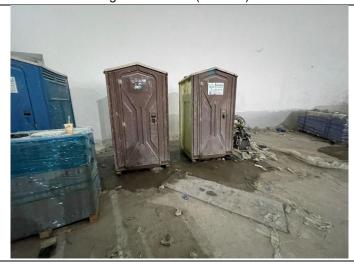
Photo 1

1. The general wastes are observed on the ground on L3. (Photo 1)

1. The contractor has been recommended to provide enough enclosed bin for general waste collection and to arrange for site cleaning to ensure the site is kept clean and tidy.

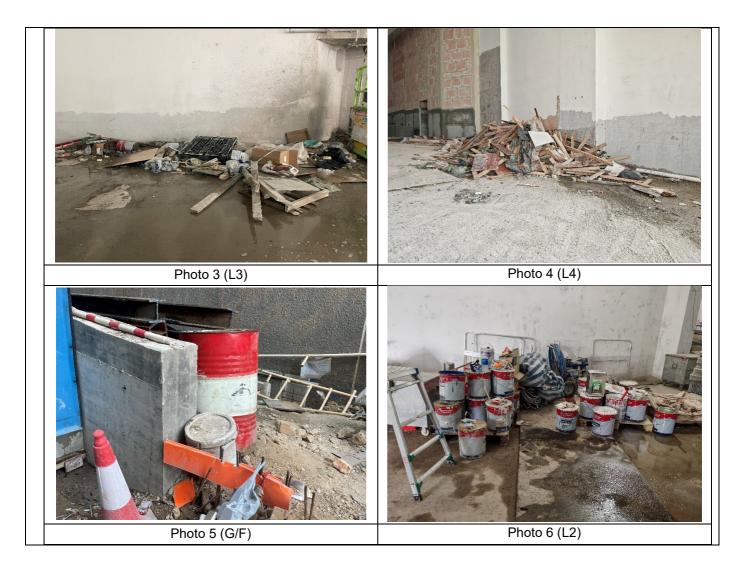
Photo 2 (G/F)

- Overflow of wastewater was observed on L3. The contractor has been recommended to maintain the drainage channel regularly to ensure its efficiency to prevent the overflow of wastewater.

- The accumulated C&D waste, chemical waste and general waste without segregation was observed on G/F, L3 & L4. The contractor has been recommended to provide different segregation areas for general, C&D and chemical waste storage, clearly label the waste storage area designated for C&D waste and increase the frequency of waste disposal to prevent waste accumulation.

- The oil drum without drip tray was observed on G/F and chemical containers on L2 were placed near to the drainage channel without drip tray. The contractor has been advised that chemical storage area should be designed far away from drainage channel and provided drip tray to prevent chemical spillage, water pollution and land contamination.

- 1. The contractor has been recommended to maintain the drainage channel regularly to ensure its efficiency to prevent the overflow of wastewater.
- 2. The contractor has been recommended to provide different segregation areas for general, C&D and chemical waste storage, clearly label the waste storage area designated for C&D waste and increase the frequency of waste disposal to prevent waste accumulation.
- 3. The Contractor has been advised that chemical storage area should be designed far away from drainage channel and provided drip tray to prevent chemical spillage, water pollution and land contamination.

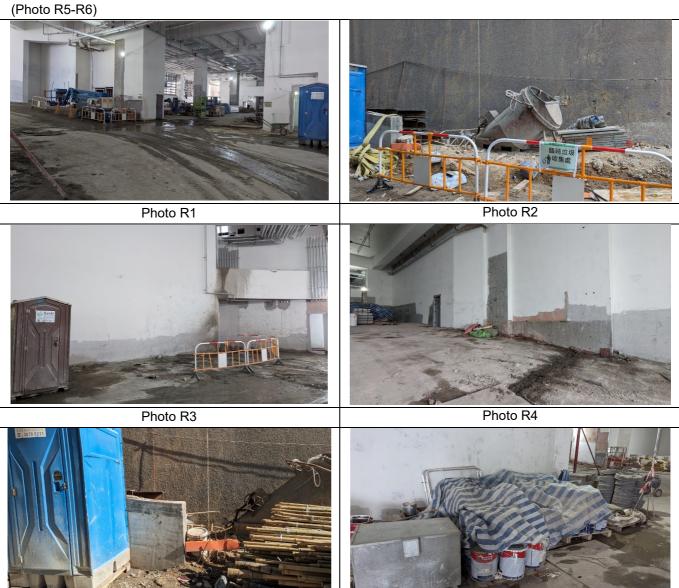
Photo R5

- 2. The accumulated waste on G/F, L3 & L4 was removed, and waste storage area was designated on G/F. (Photo R2-R4)
- 3. The oil drum on G/F was removed and drainage under chemical storage area was covered properly on L2. (Photo R5-R6)
