# Environmental Team Services for Contract No. SS H504 Design and Construction of Chai Wan Government Complex and Vehicle Depot

## 36<sup>th</sup> Monthly EM&A Report (October 2024)

**Contract No. SS H504  
Design and  
Construction of Chai  
Wan Government  
Complex and Vehicle  
Depot**

36<sup>th</sup> Monthly EM&A Report

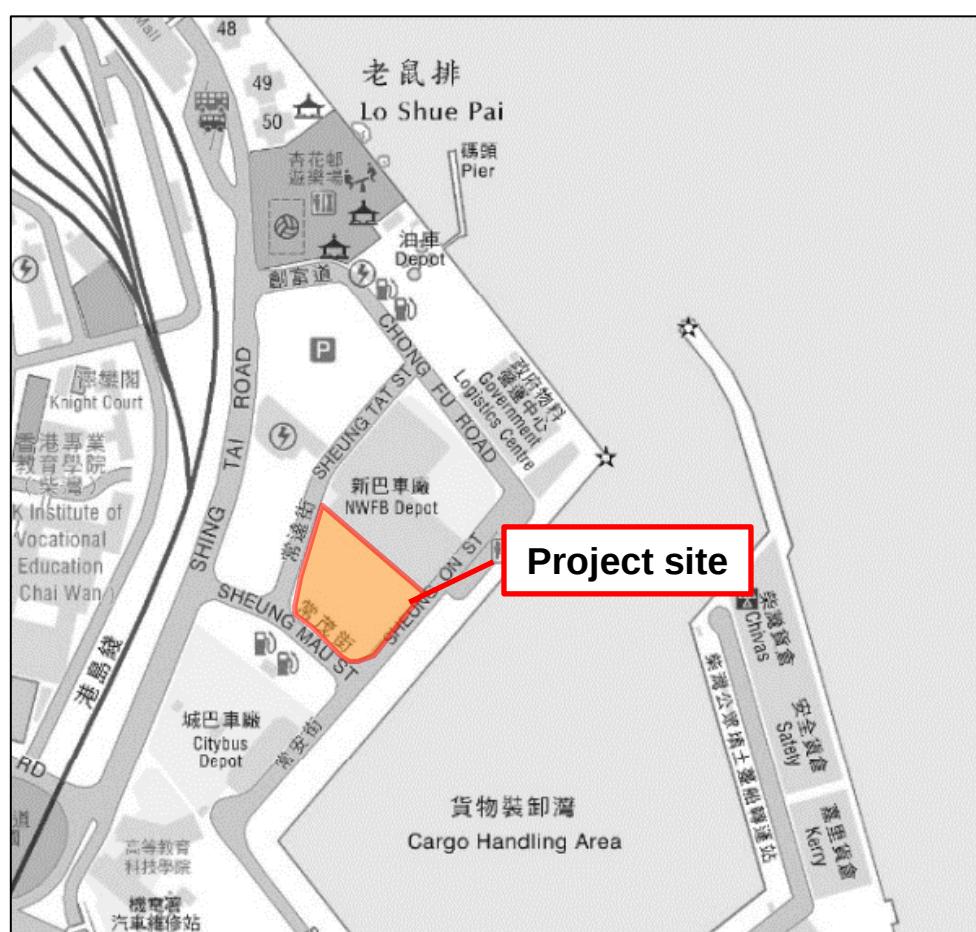
**Figure 1-1 A layout plan of the Project**

2.2.1 The scope of works of the Project, which is a Designated Project under the EIA Ordinance (EIAO), will construct joint user building comprising the government office, store, laboratory, transport pool and vehicle depot facilities in Chai Wan District. The Site is bounded by NWFB Depot to the north, Sheung On Street to the east, Sheung Mau Street to the south and Sheung Tat Street to the west. A layout plan of the Project is provided in **Figure 1-1**.

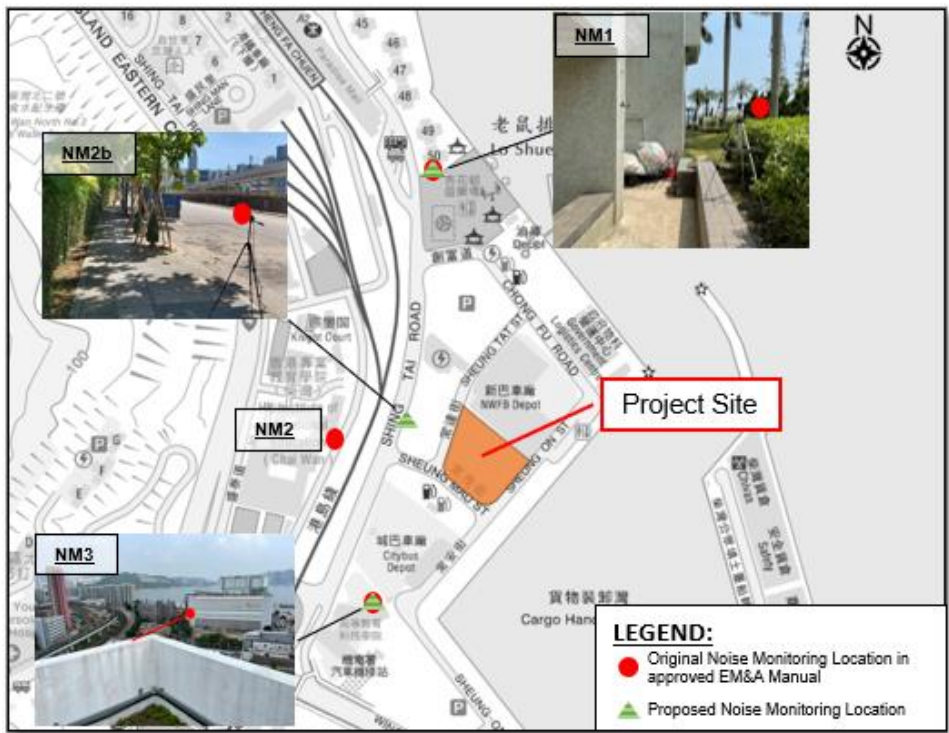
Figure 3-1 Location of Noise Monitoring Stations (NM1, NM2b and NM3)

Lamp Post no. 47447 at Sheung Mau Street (NM2a), which is located between project site and original noise monitoring location, Hong Kong Institute of Vocational Education (Chai Wan) - Academic Block (NM2), is found suitable and available to be an alternative noise monitoring location for NM2. Also, NM2a, which has a direct line of sight towards project site (where construction works will be carried out and likely to have noise impacts), is located closer to project site than NM2 and thus considered as a representative noise monitoring location. Monitoring position at NM2a is proposed at 2m above ground due to security concerns and minimize the road traffic noise contribution. Noise measurement at NM2a will be considered as free-field and a correction of +3dB(A) would be made to the noise monitoring results. The alternative location of NM2a, were therefore proposed and agreed by the Independent Environmental Checker (IEC).

Due to the adjustment of the location of NM2a to NM2b, the measured noise level at NM2b would represent the noise levels at NM2.

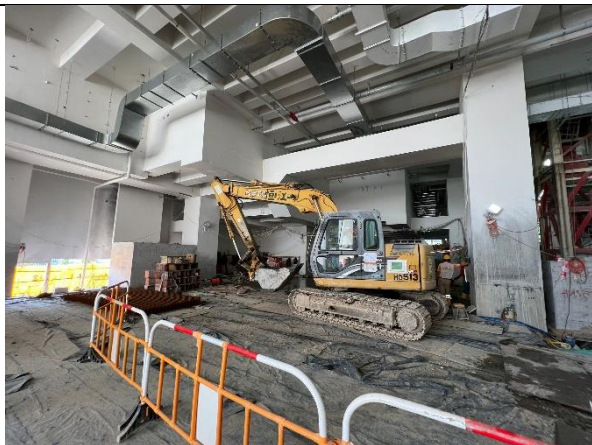
Photo R2

1. Dusty material was removed. (Photo R2)
2. The accumulated C&D waste was disposed and waste skip was provided. (Photo R3)

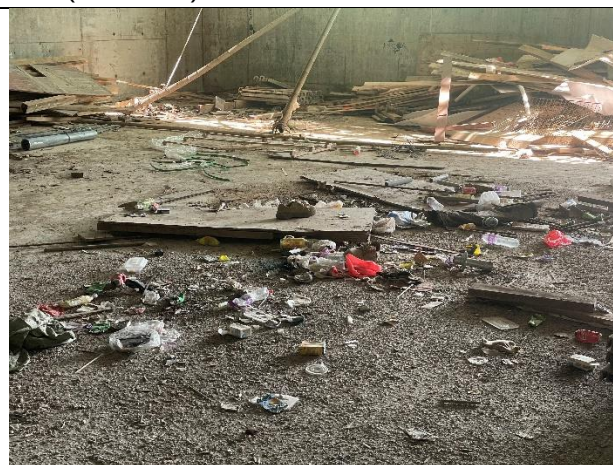
1. General waste shall be collected and stored in enclosed bins. (Photo 1-2)

- The wastewater was accumulated at the site entrance. The Contractor has been reminded that the wastewater from wheel washing should be directed properly to prevent wastewater runoff from the site entrance.
- The general waste was observed on the floor. The Contractor has been advised to arrange for more site cleaning and to provide more enclosed bins to keep the site clean and tidy and to collect general waste properly.

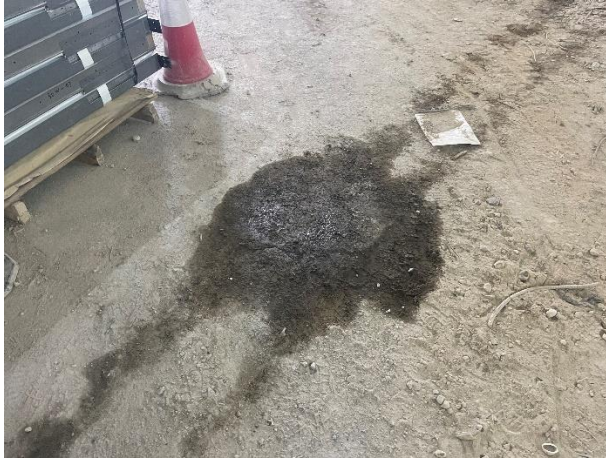
Photo 1

1. Oil stain is observed in the work area. (Photo 1)

- Oil stain was observed in the work area. The Contractor has been reminded that oil stain should be cleaned immediately and disposed of as chemical waste.

1. The contractor has been reminded that oil stain should be cleaned immediately and disposed of as chemical waste.

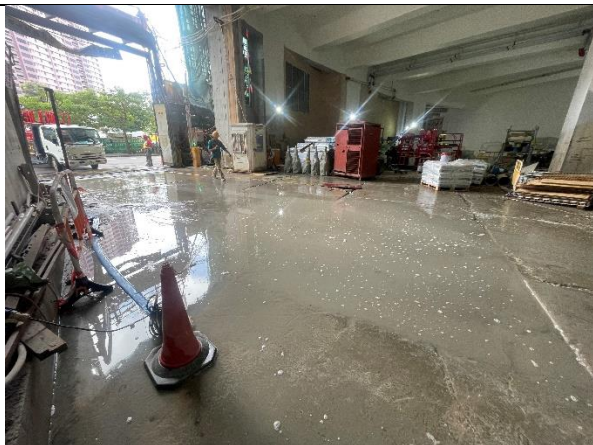
Photo 1

1. The wastewater is accumulated at the site entrance. (Photo 1)
2. The general waste is observed on the floor. (Photo 2-4)

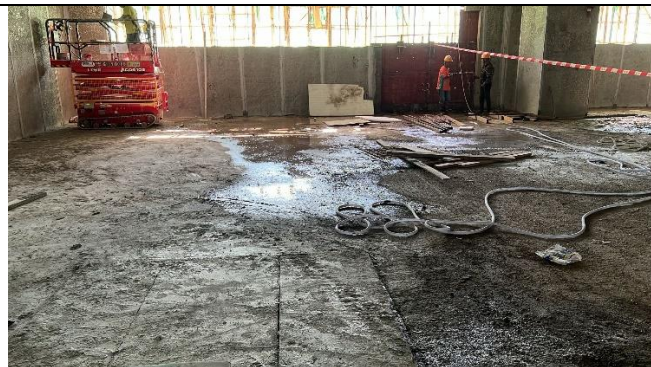
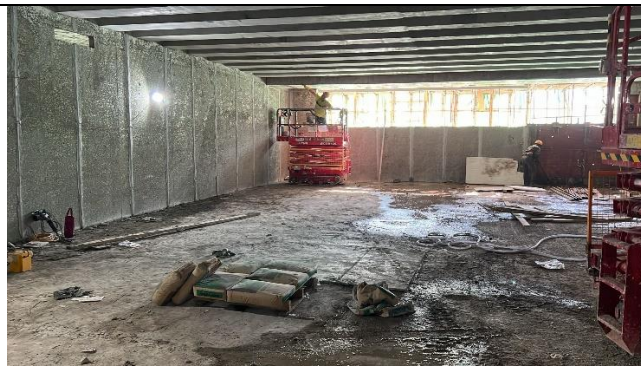
1. The general waste was removed and cleaned. (Photo R1-R2)

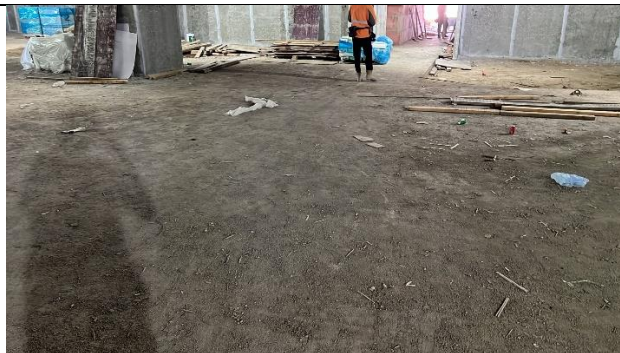
Photo R3

1. The oil stain was removed. (Photo R3)

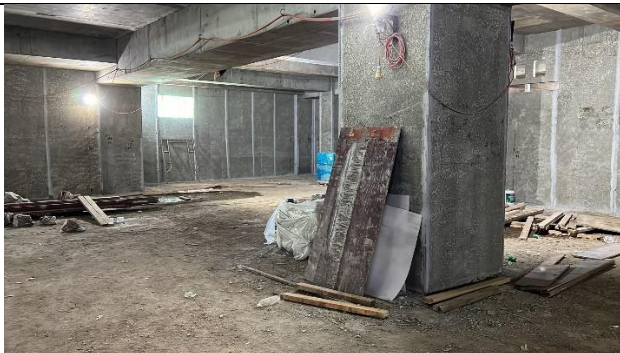
Photo R4

1. The general waste was removed and cleaned. (Photo R4)

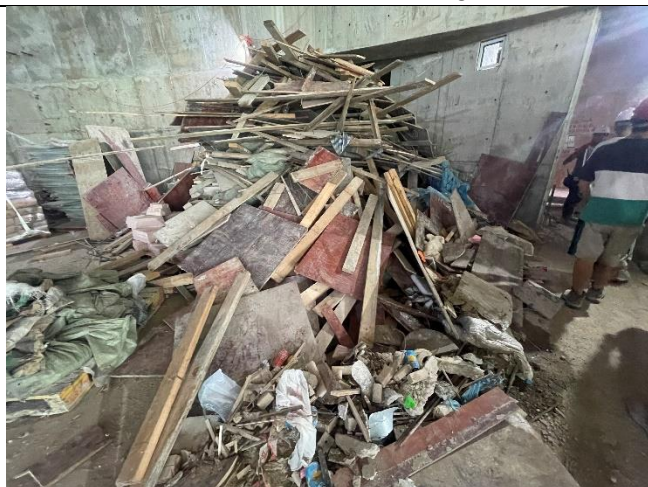
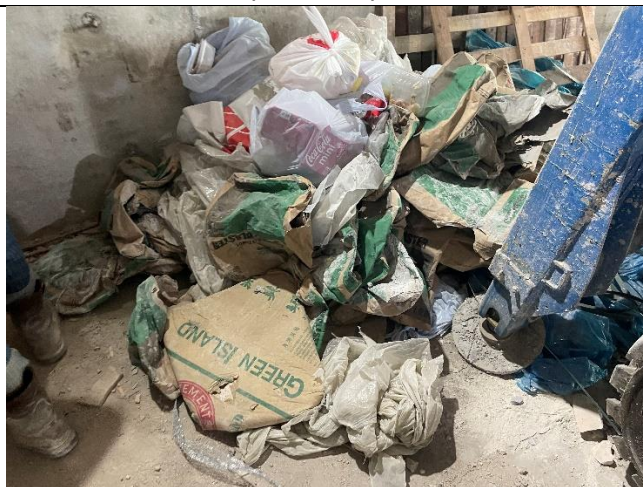
1. The accumulated of C&D waste with general waste is observed on the floor. (Photo 1-2)

- The accumulated of C&D waste with general waste was observed on the floor. The Contractor has been advised to increase the frequency of waste disposal to prevent waste accumulation and to provide enclosed bins or a segregation area for general waste to ensure proper segregation.
