Environmetnal Team Services for Contract No. SS H504 Design and Construction of Chai Wan Government Complex and Vehicle Depot

47th Monthly EM&A Report (September 2025)

Contract No. SS H504
Design and
Construction of Chai
Wan Government
Complex and Vehicle
Depot

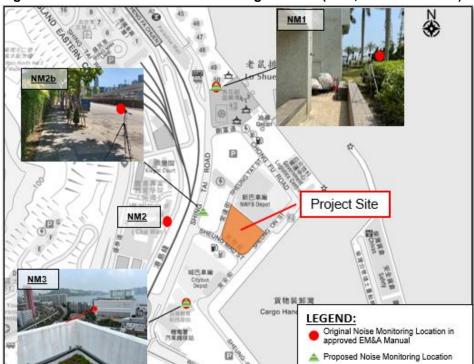
Location of Noise Monitoring Stations (NM1, NM2b and NM3)

To respond to the comment raised by EPD on monitoring location of NM2a by email dated 23 May 2022 and site meeting on 6 June 2022, the monitoring location of NM2a was adjusted to the pedestrian road at Shing Tai Road (NM2b) which is located between project site and original noise monitoring location, Hong Kong Institute of Vocational Education (Chai Wan) - Academic Block (NM2). Compared with NM2a, NM2b is far away from the traffic light and therefore should be able to minimise the traffic noise issue. This arrangement was started from 28 June 2022 and has been agreed by the Independent Environmental Checker (IEC). Noise measurement at NM2b will be considered as free-field and a correction of +3dB(A) would be made to the noise monitoring results.

Due to the adjustment of the location of NM2a to NM2b, the measured noise level at NM2b would represent the noise levels at NM2.
